UNITED STATES DISTRICT COURT WESTERN DISTRICT OF TEXAS AUSTIN DIVISION

JON R. DEUTSCH	§	
	§	CIVIL ACTION NO. 1:15-CV-1159
Plaintiff	§	
	§	
VS.	§	
	§	
SWITCH 1080 FOODS, LLC	§	
	§	
Defendant	§

COMPLAINT

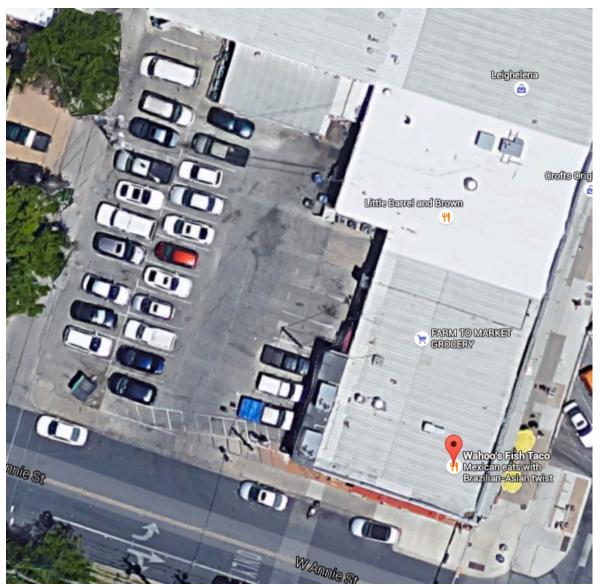
Fig. 1 - Overhead view of WAHOO'S FISH TACO AUSTIN IN 2015.

Satellite Images from *Texas General Land Office, Texas Orthoimagery Program, U.S. Geological Survey, 2015.* Note: This property Zero ADA-Compliant disabled parking spaces near the entrance. Under the ADA, this property must have 1 ADA-Compliant Van Accessible Parking space (96" Wide with 96" Side Access Aisle).

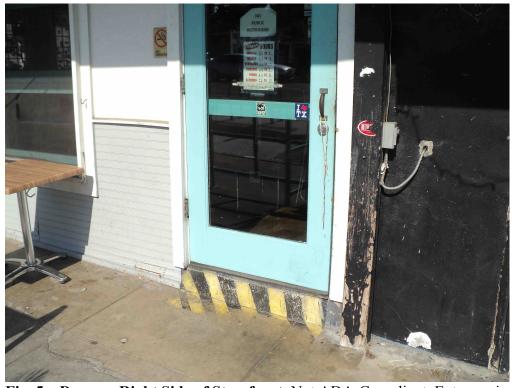
Fig. 5 – Door on Right Side of Storefront. Not ADA-Compliant. Entrance is Not Usable by Disabled Patrons Because of Step. No Ramp. Threshold Exceeds ½".
